International Symposium  
Qualification of dynamic analyses of dams and their equipments  
and of probabilistic assessment seismic hazard in Europe  
31th August – 2nd September 2016 – Saint-Malo

Session 2: Performance of CFRD & AFRD

# Performance and analysis of CFRD and AFRD during earthquake

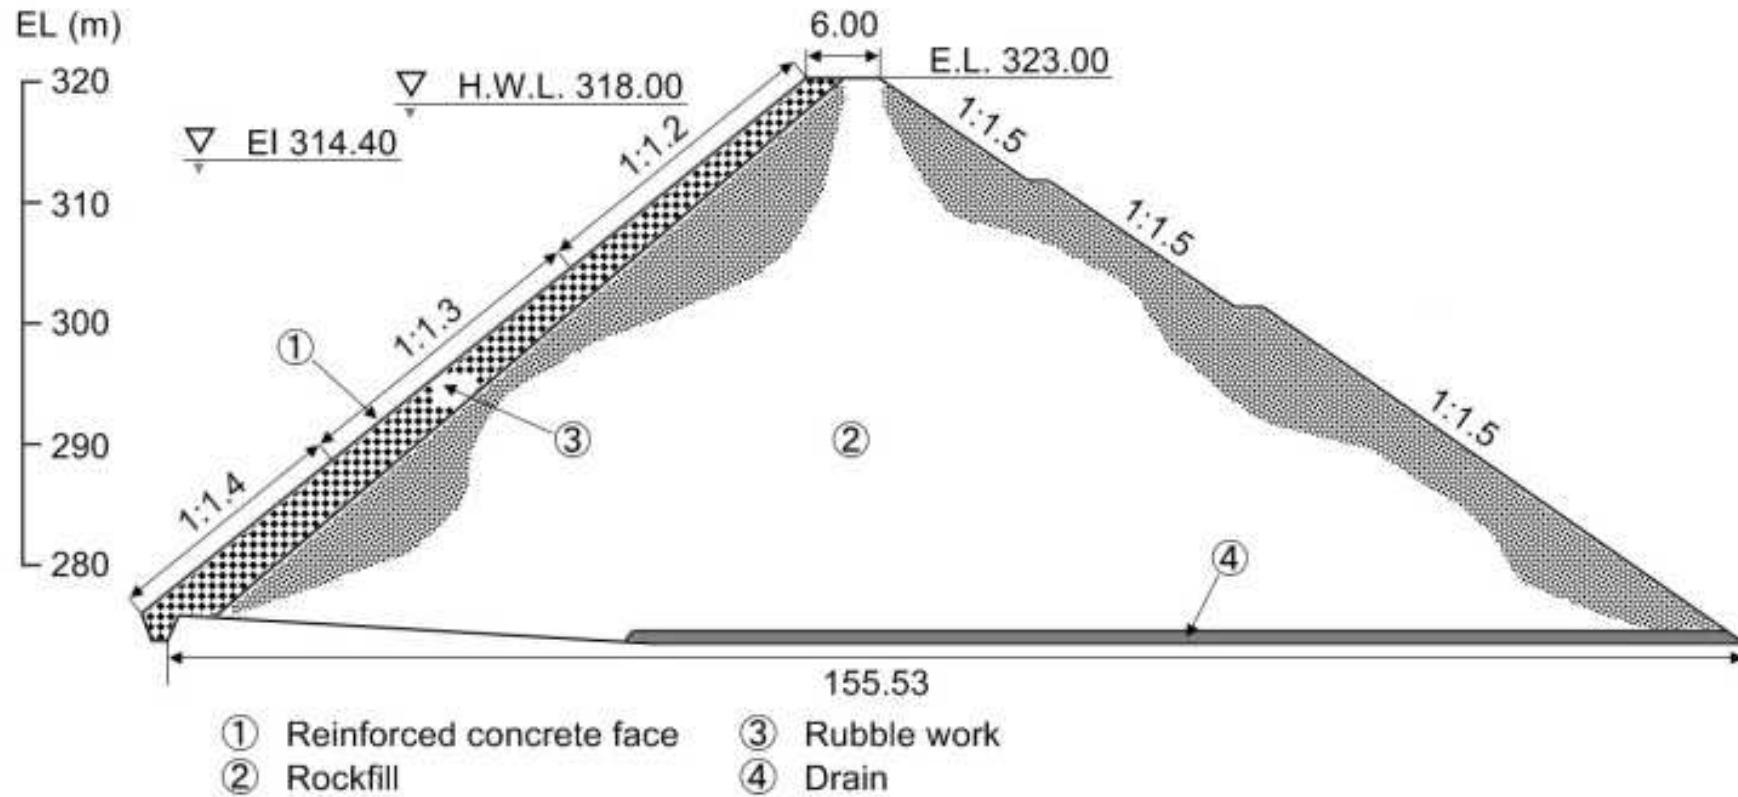
Typical cross section

# Ishibuchi Dam CFRD

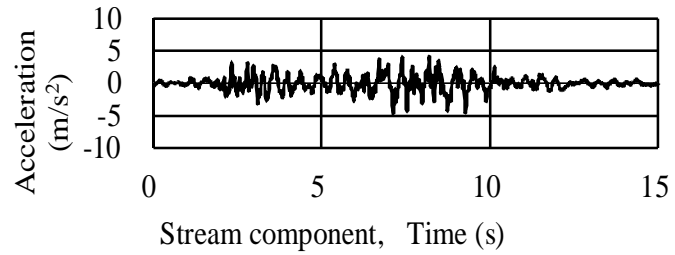
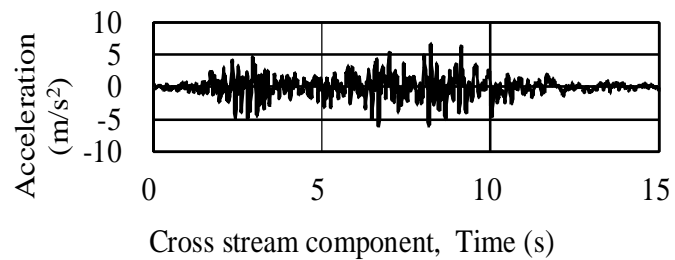
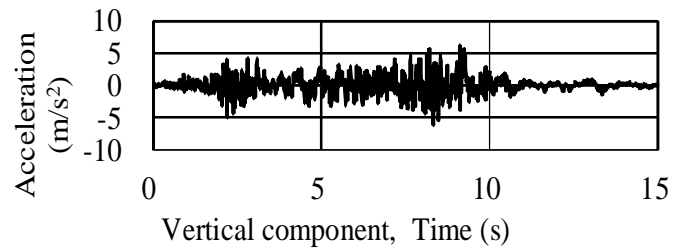
Foundation

# Accelerograms

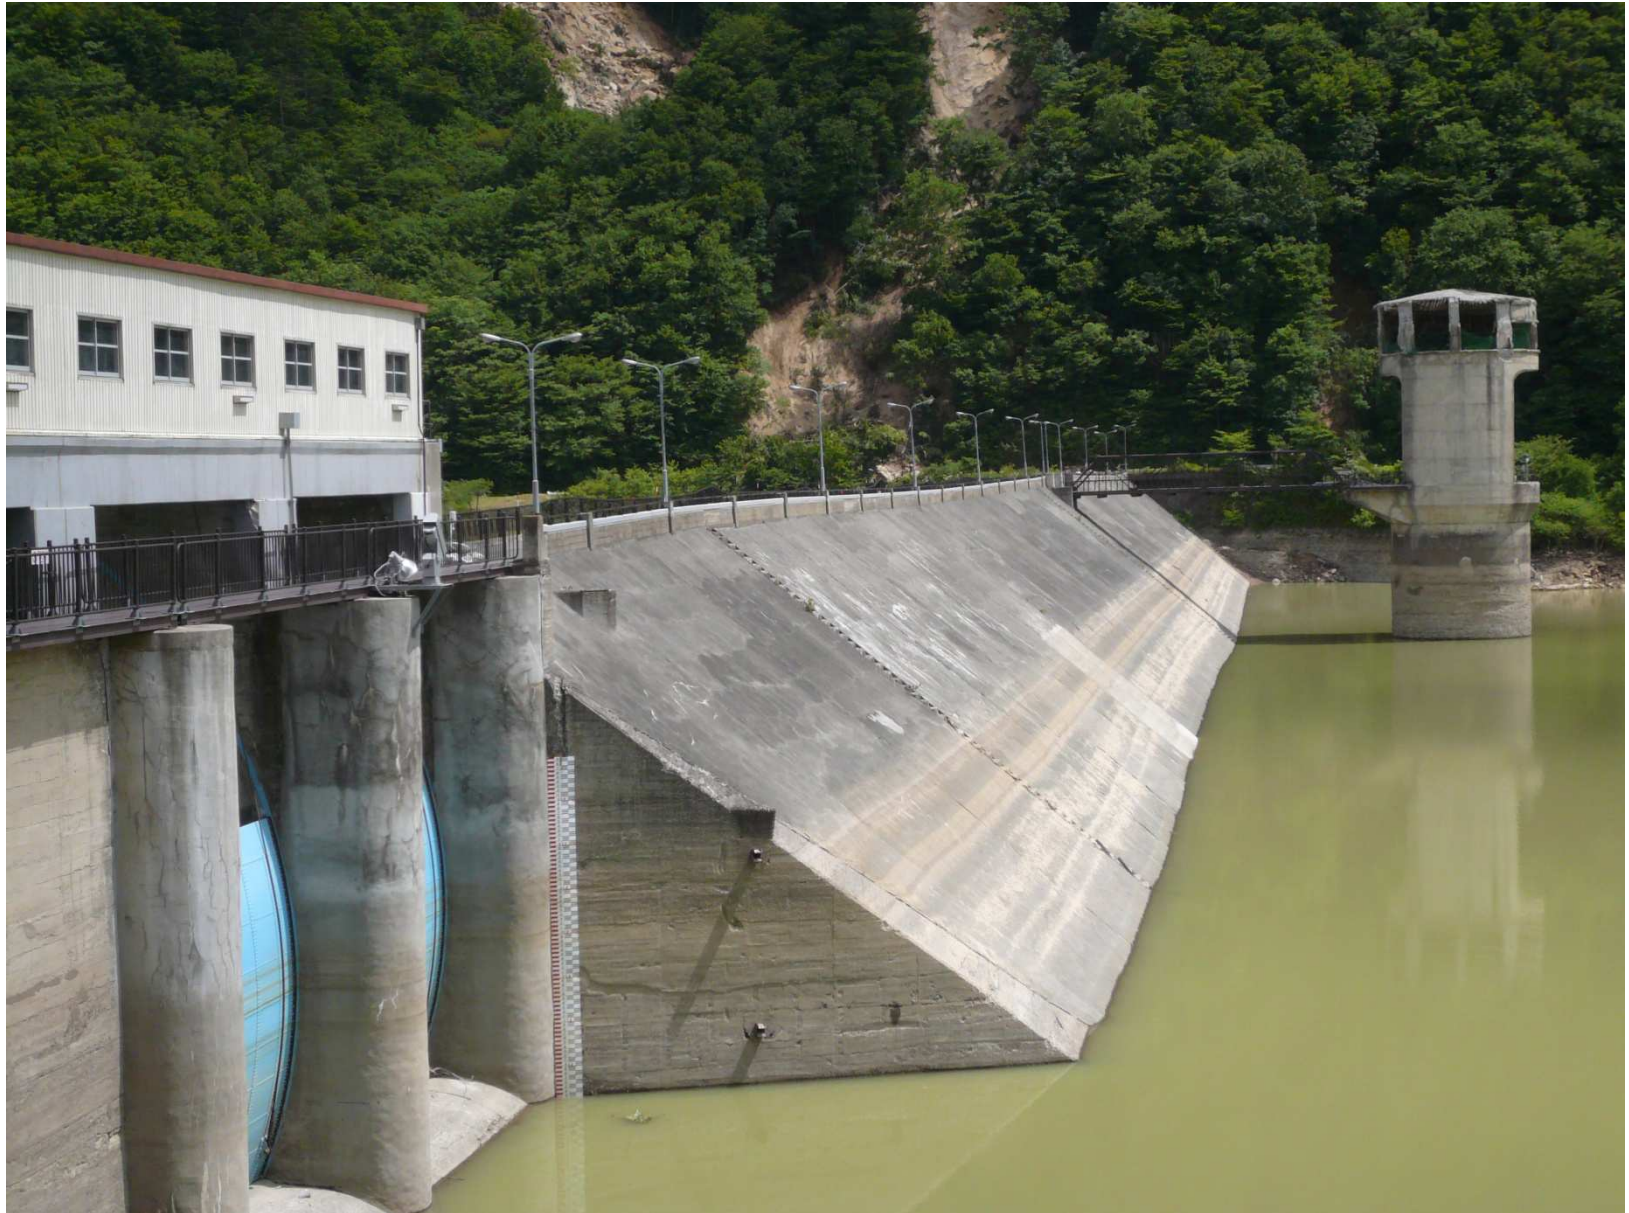
# Concrete face just after the Quake

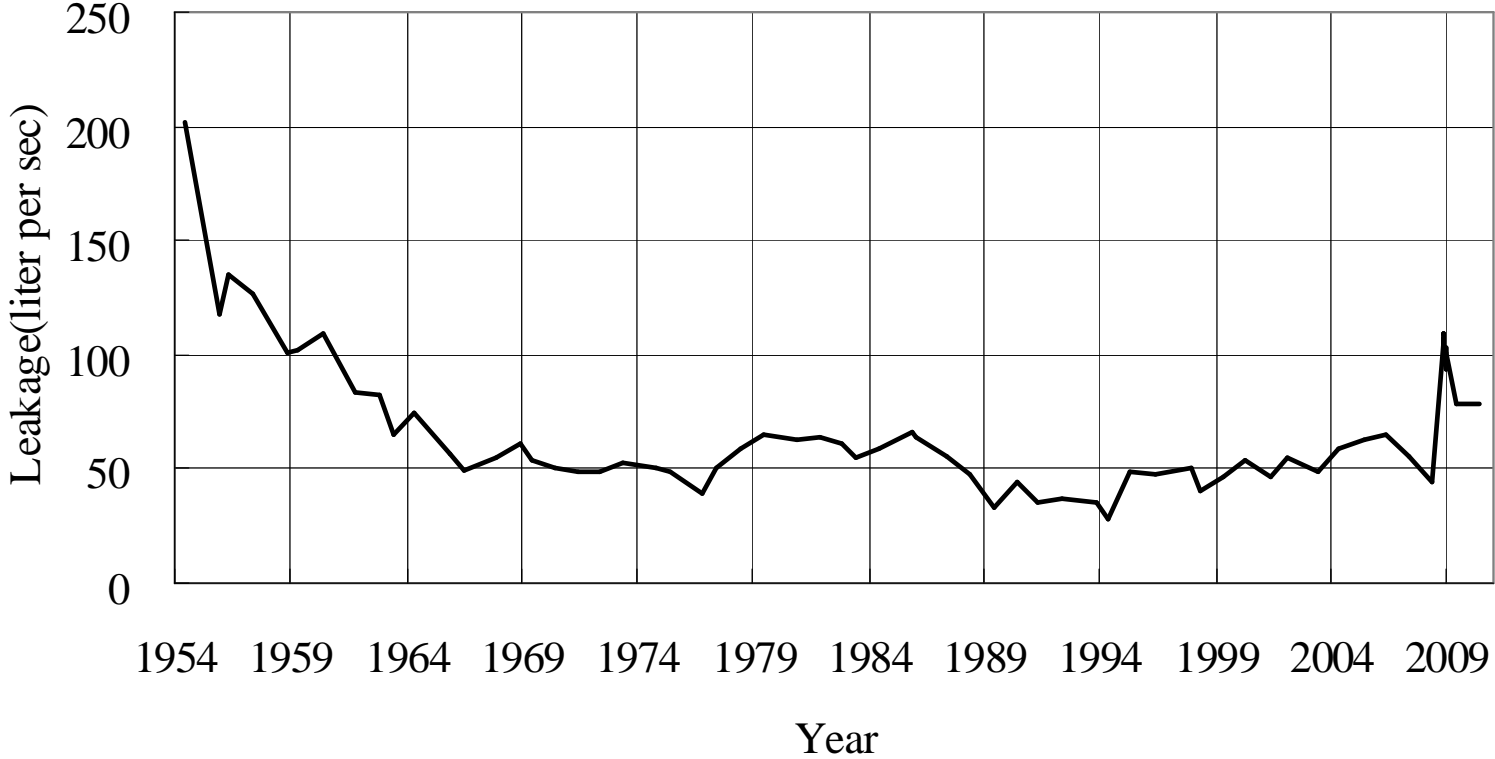
# Leakage with time

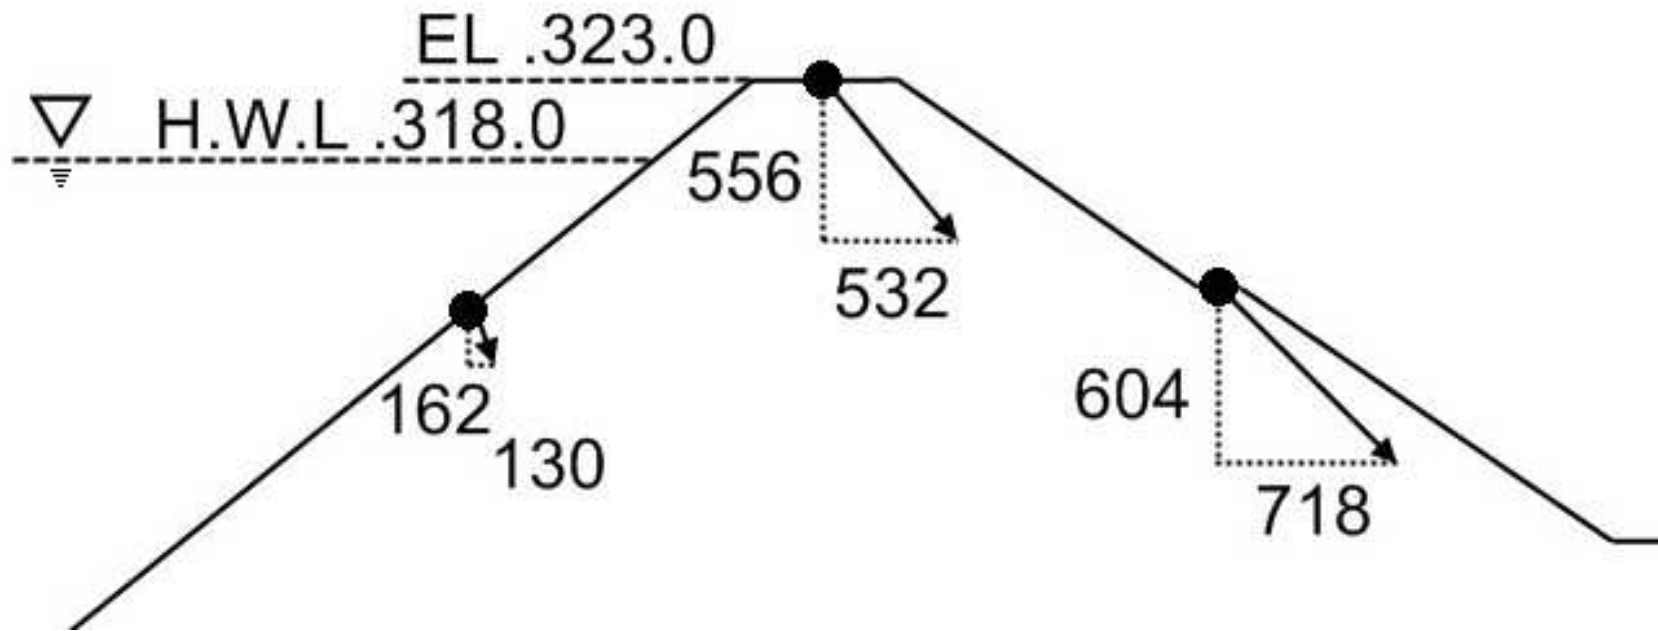
# Deformation due to the quakae

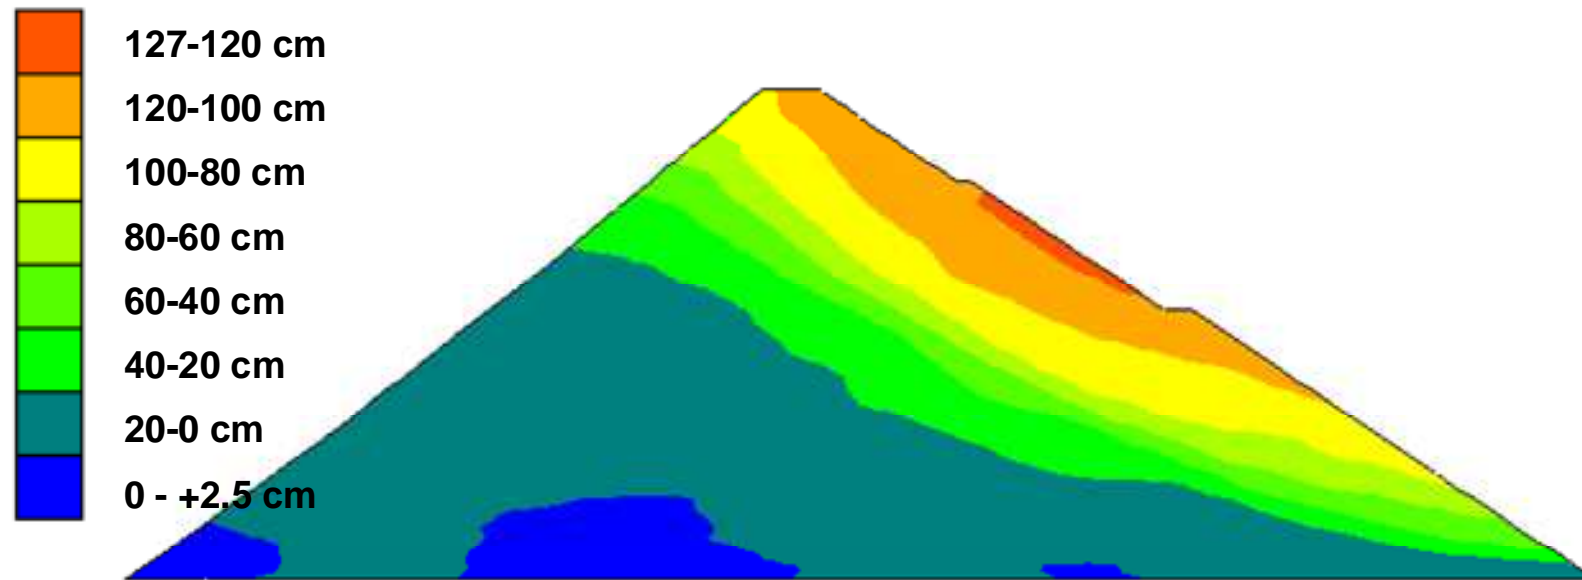
# Horizontal permanent deformation

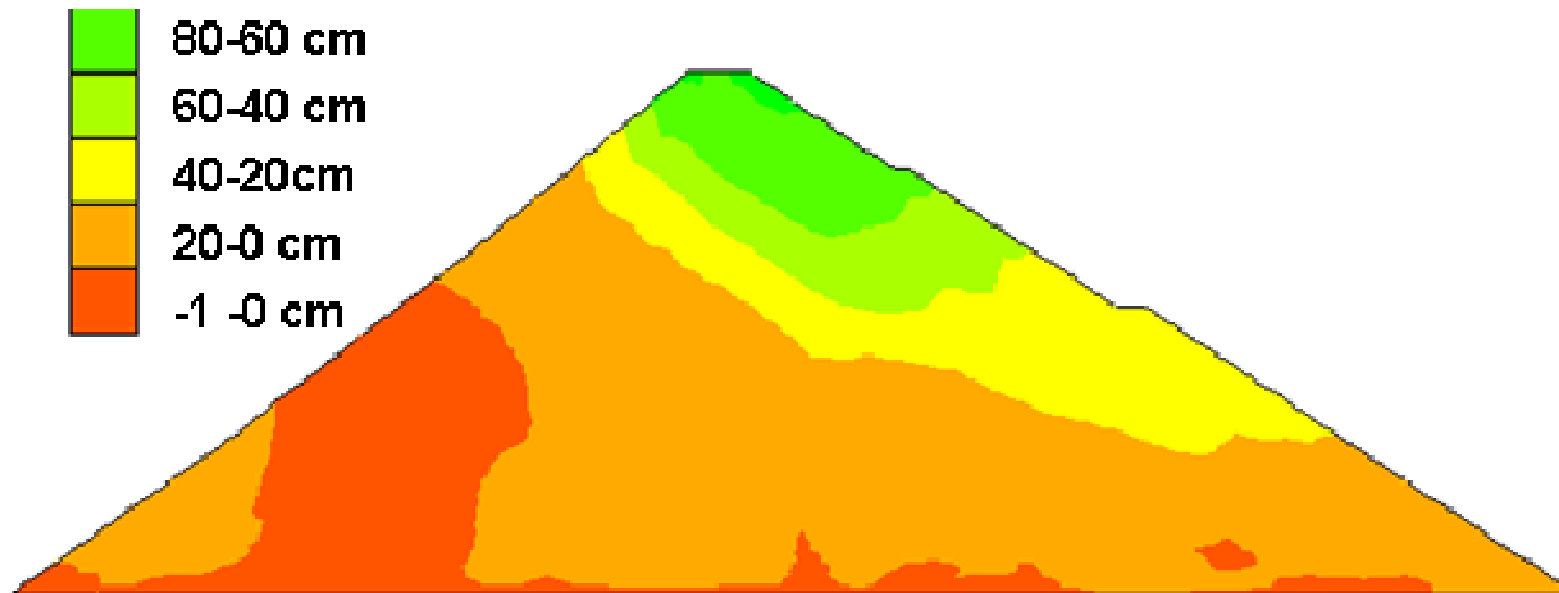
# Vertical permanent defomation

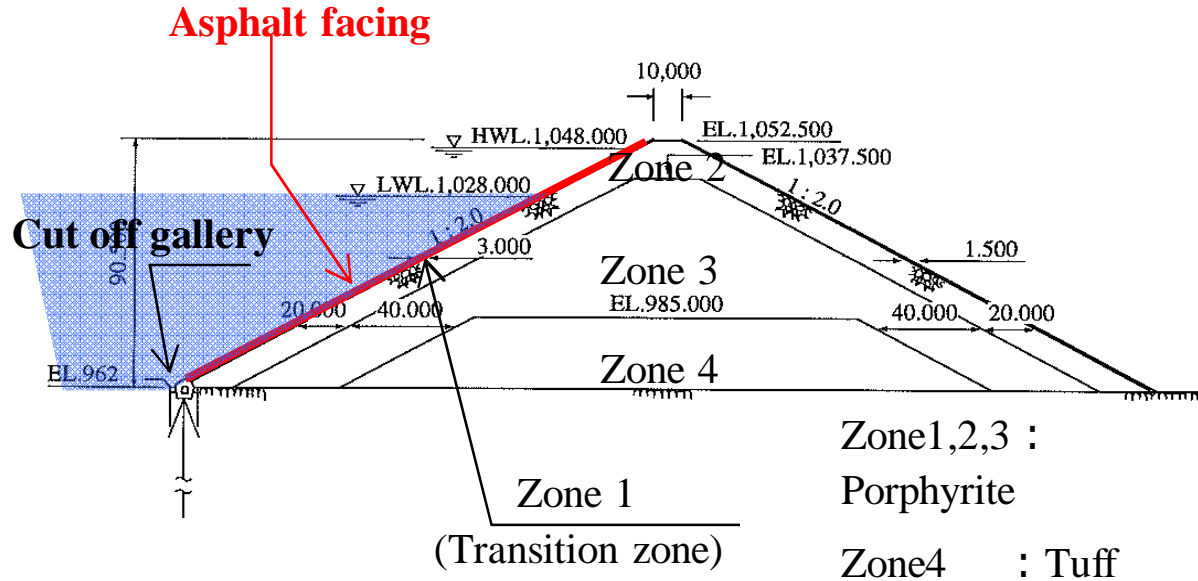
## (b) Cross section of the Dam

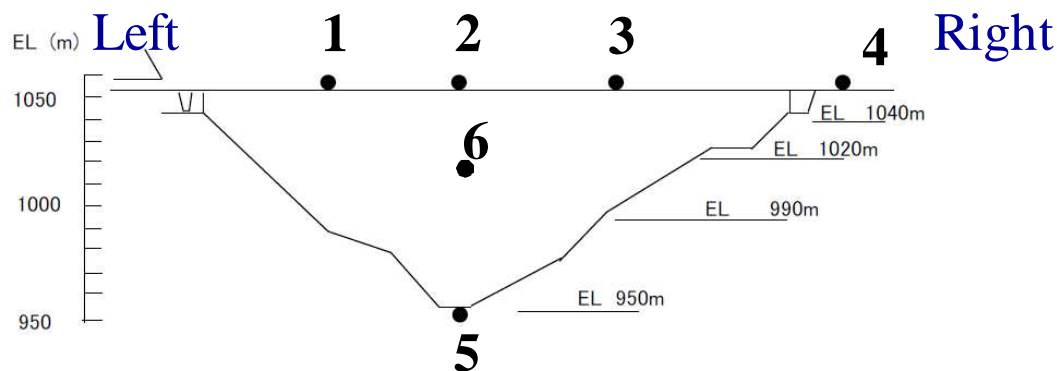
Max. Acceleration at the crest and inner part of the Yashio dam

1	2	3	4	6
Stream	174	253	252	66	125
Dam axis	157	185	104	66	132
Vertical	105	175	156	43	115

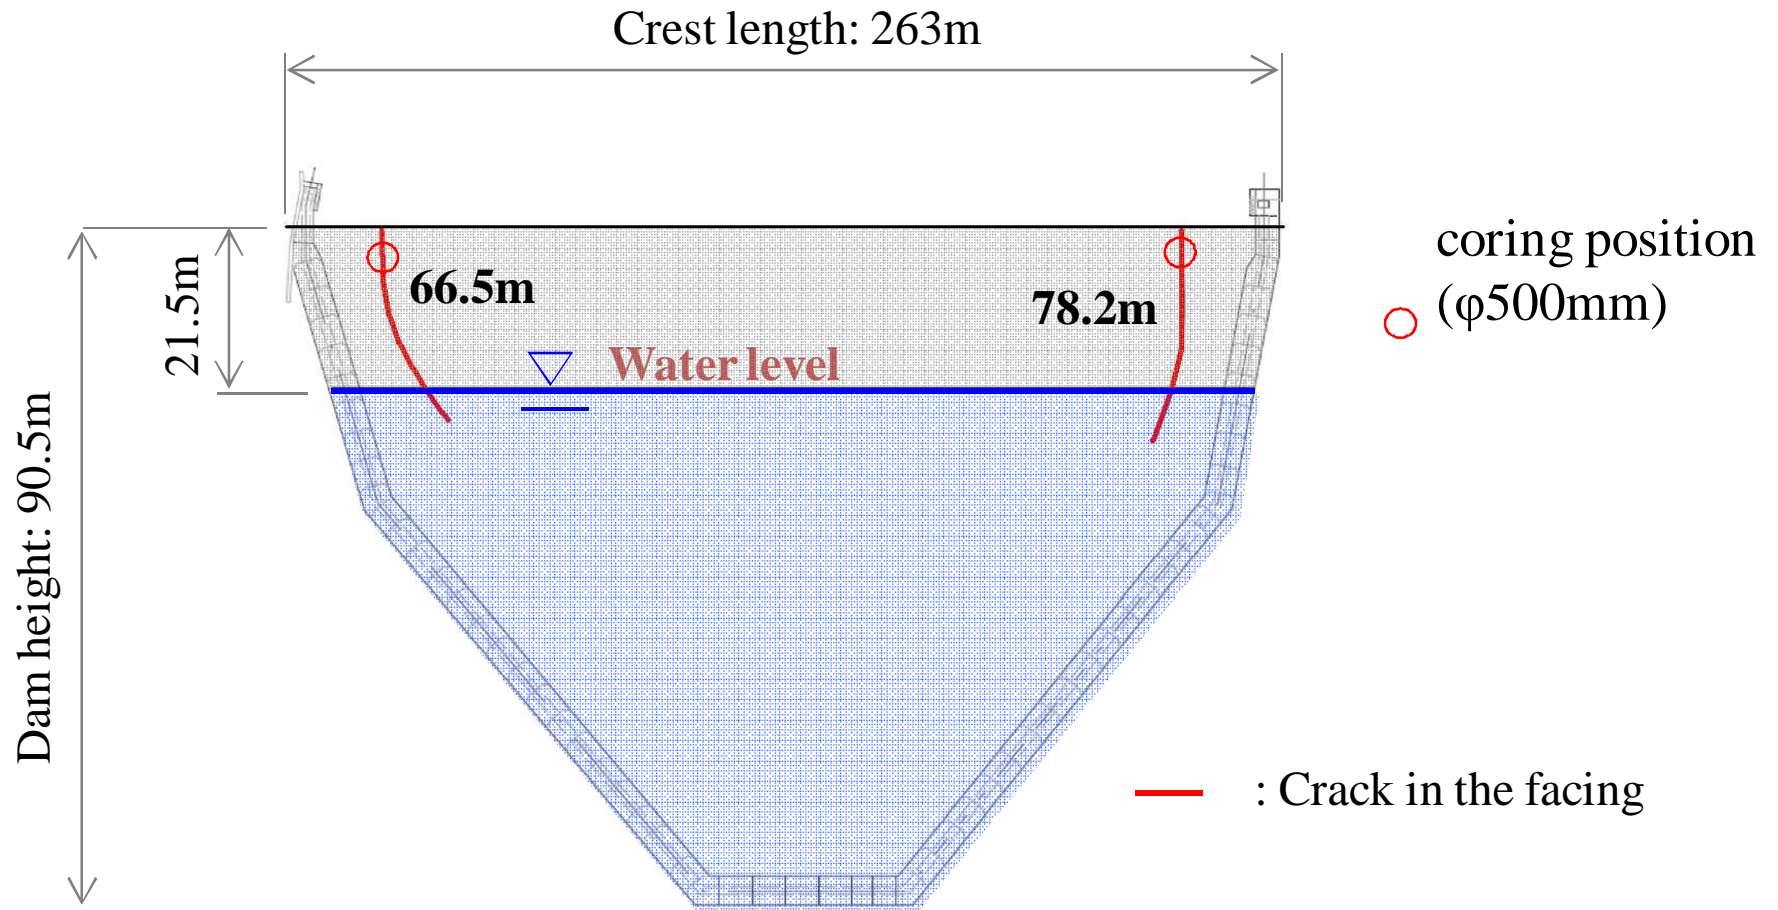
Fig – Dam front view (asphalt facing)

## (b) Cracks in the Asphalt Facing

Maximum water leakage through the cracks of the upper impermeable layer was about 300 liter/ min.

- The cracks of the asphalt facing emerged at local areas of the joints of curve of crest pavement road in Yashio AFRD and the boundary between the embankment and the excavated foundation in Numappara AFRD. The leakages from the cracks were not much to threat the safety of the dam and they were repaired successfully afterwards. The prudent design is necessary for the junction of concrete structures and the asphalt facing. The compaction of rockfill is most important to minimize deformation due to earthquakes. The adequate outlet structures can facilitate remedial works by prompt dewatering after earthquakes.

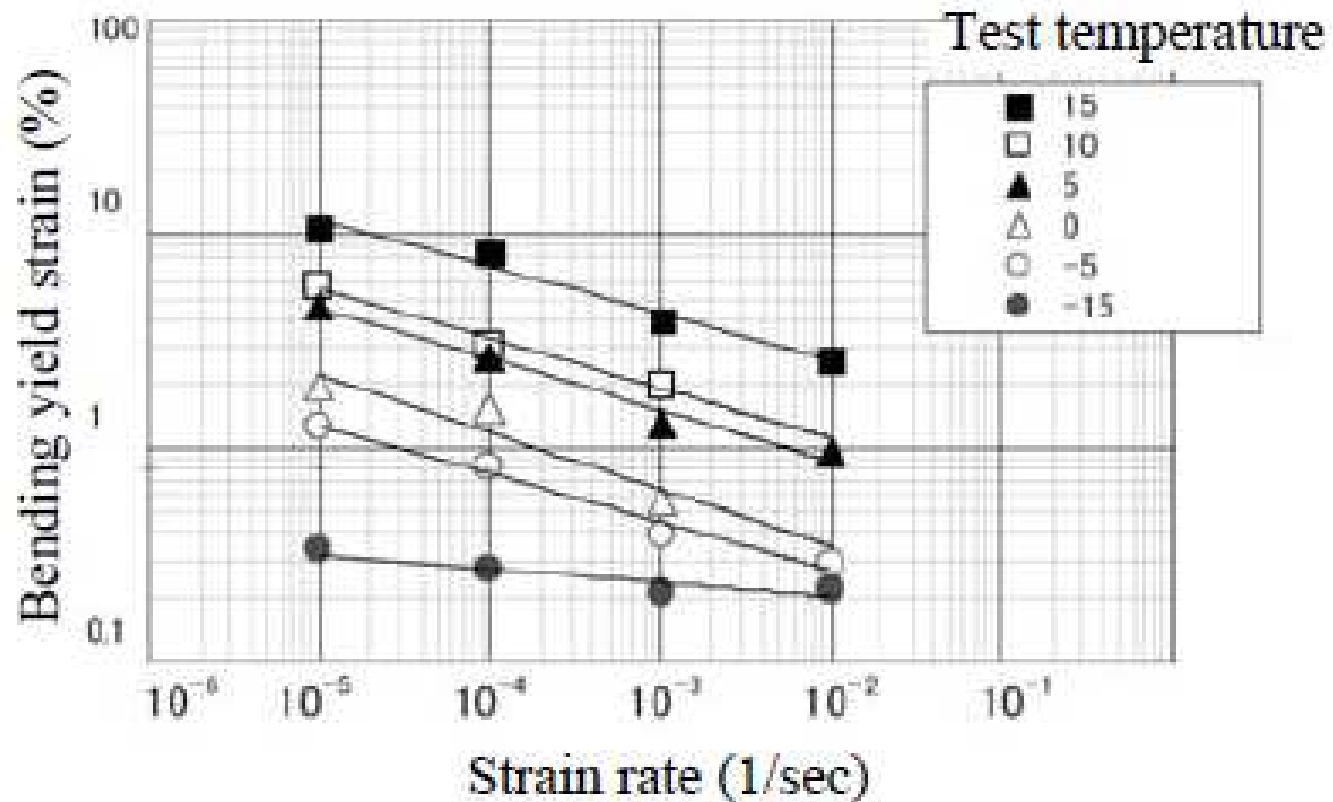
# Tensile strain capacity of asphaltic concrete with strain rate and temperature

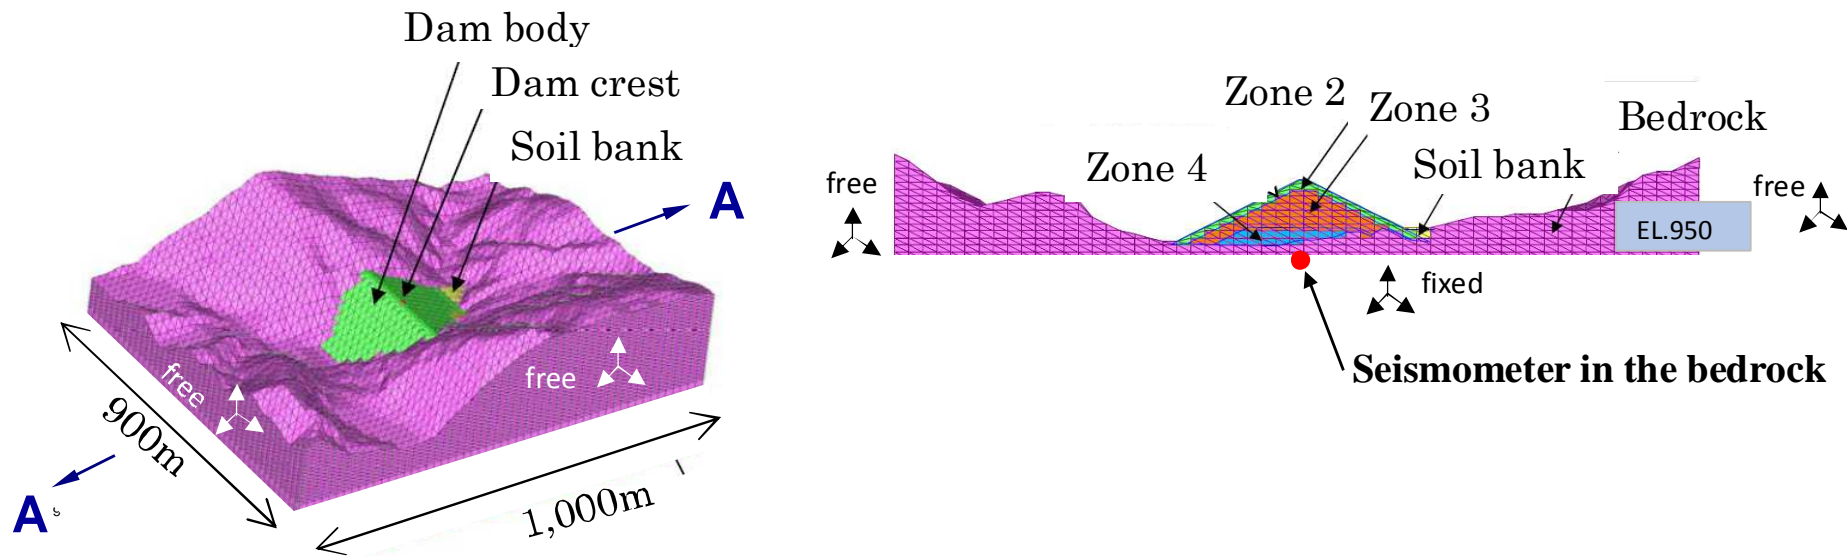
#### A – A cross section

A reproduction analysis using a seismic wave record in the bedrock to pursue the crack mechanism:

Boundary condition of this analysis

- Displacement of the base of the model was fixed.
- Displacement of the side of the model were not fixed.
- Hydrodynamic pressure : Zanger's formula.

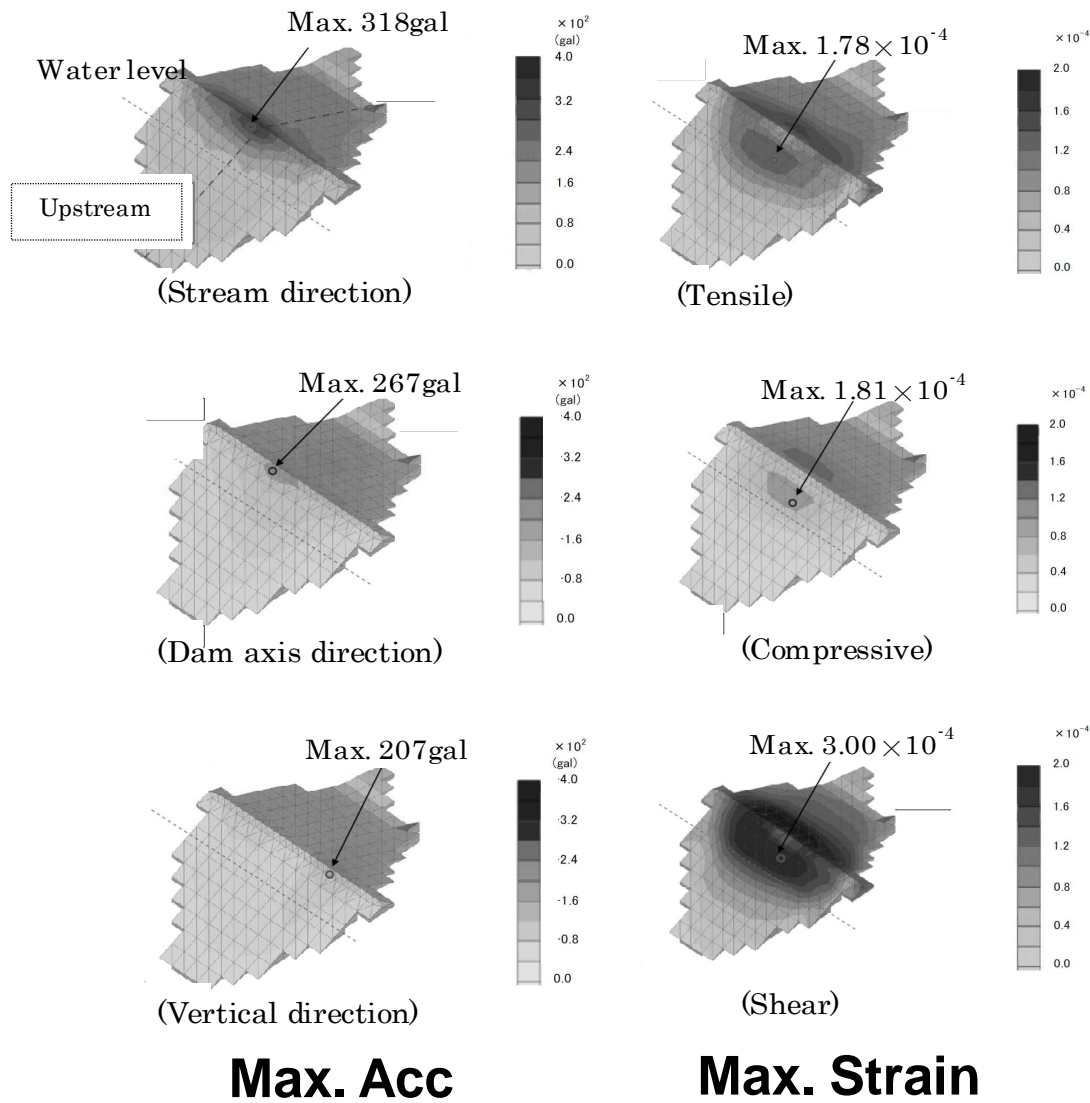
# □ Result of reproduction analysis, acceleration

Acceleration was reproduced slightly bigger than the observed record.

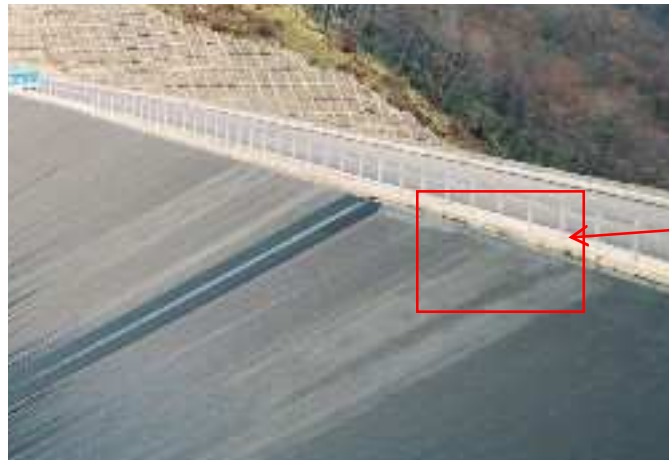
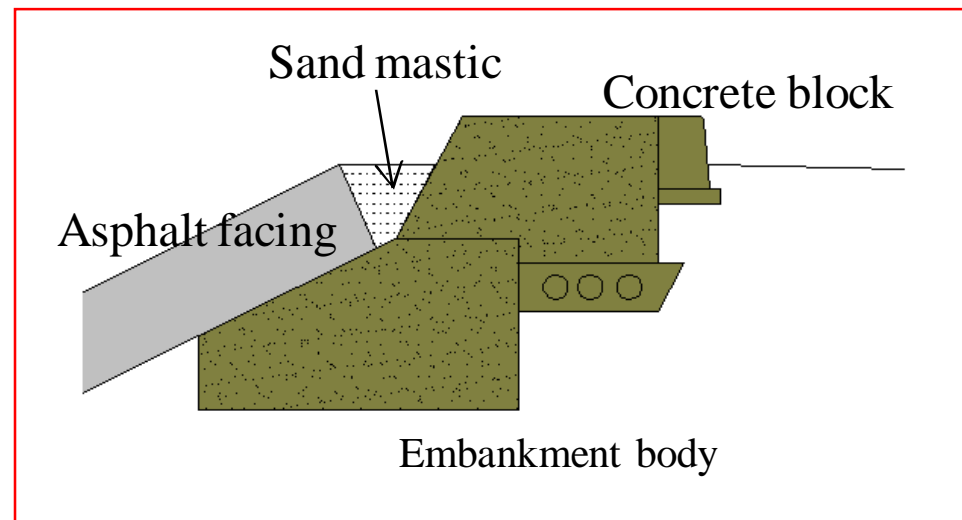
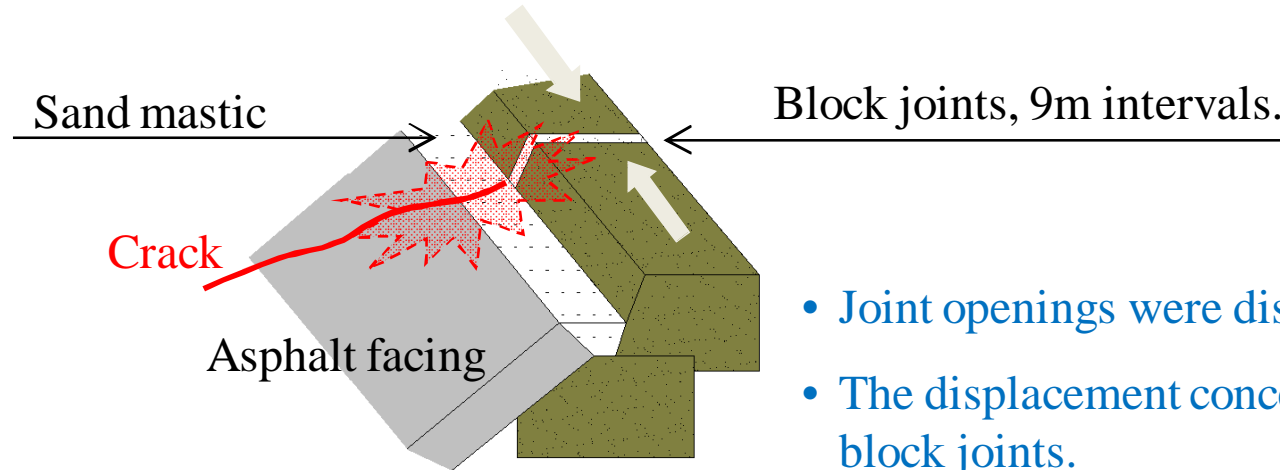
## ii. Detail structure at the dam crest

- Joint openings were displaced by the earthquake;
- The displacement concentrated strains near the block joints.

These things were confirmed by the result of the reproduction analysis.

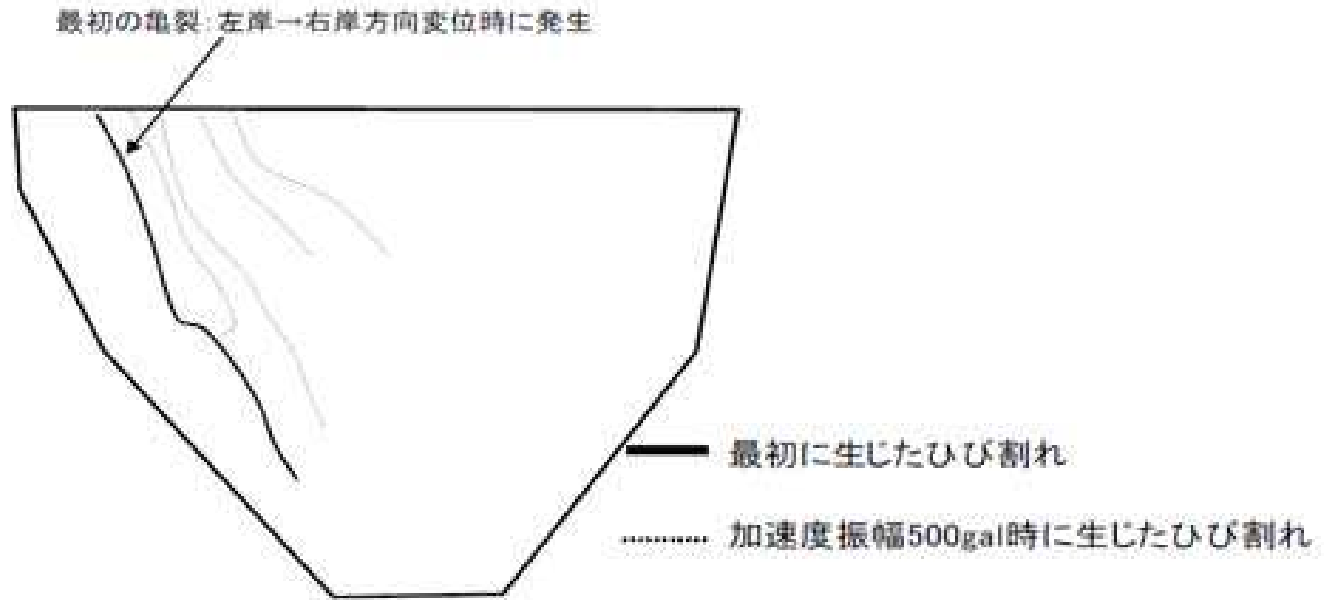
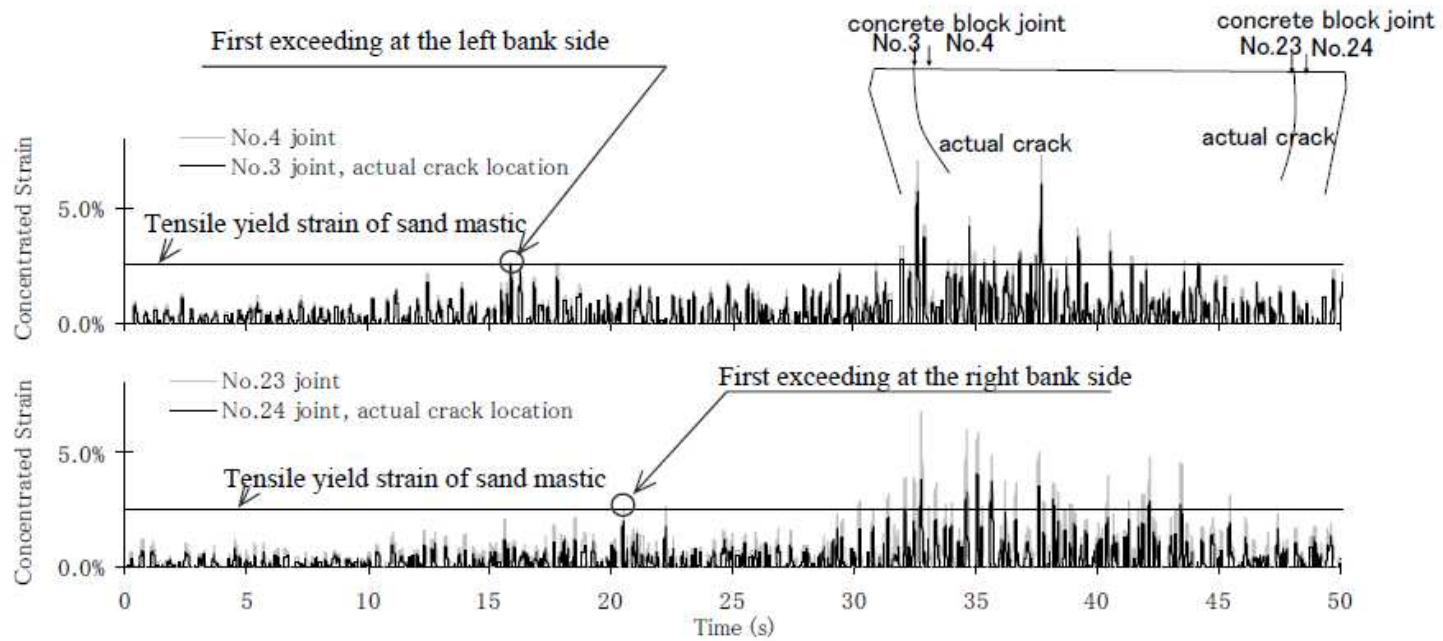
Figure 11. Concentrated strain by estimates at the actual crack location.

# Physical model test on shake table

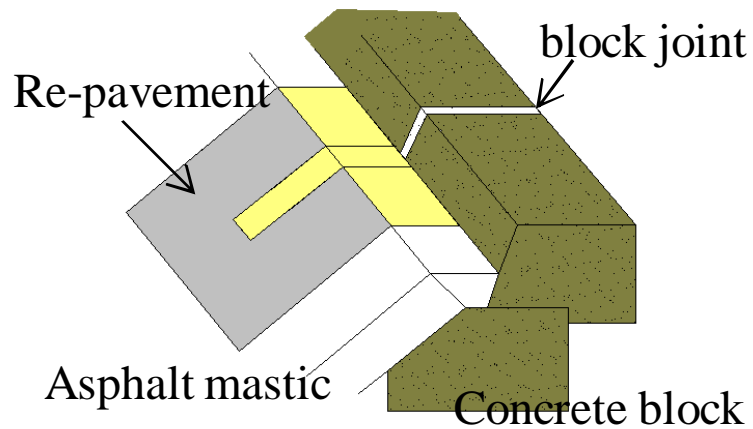
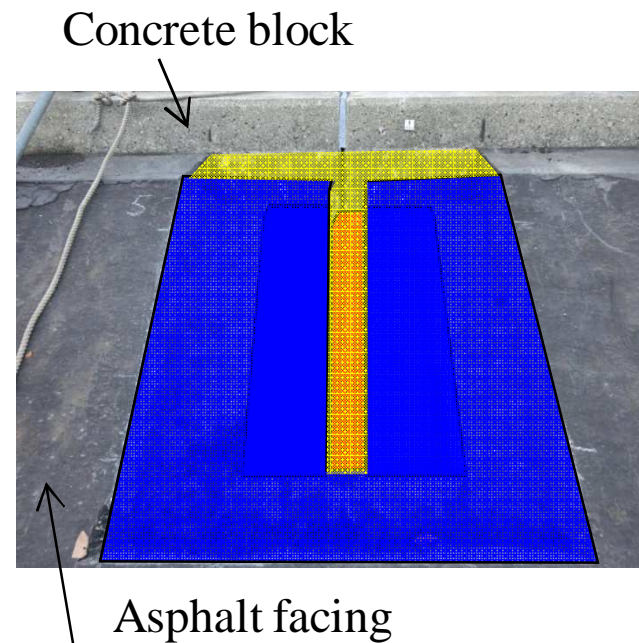
## 6. Reinforcement work at the crest

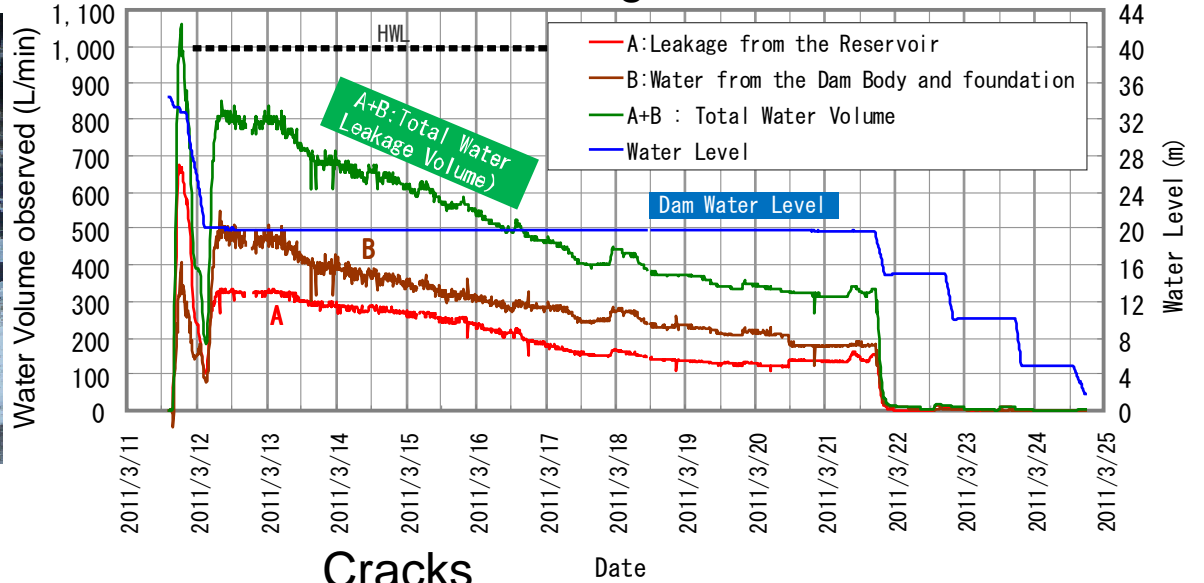
## Leakage

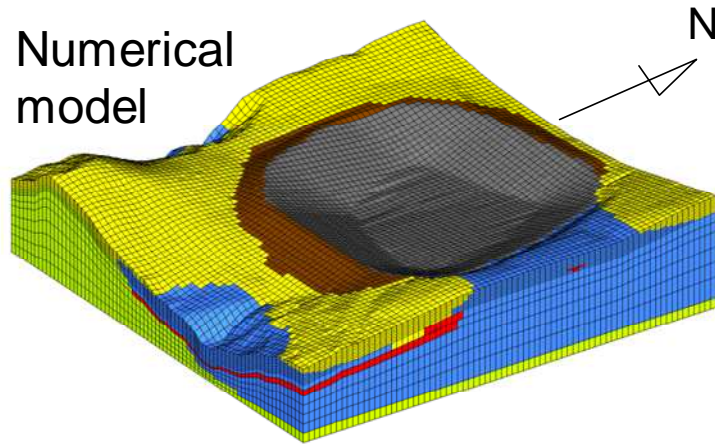
Numerical model

- Facing
- Weak foundation
- Embankment
- Others
- Rock foundation

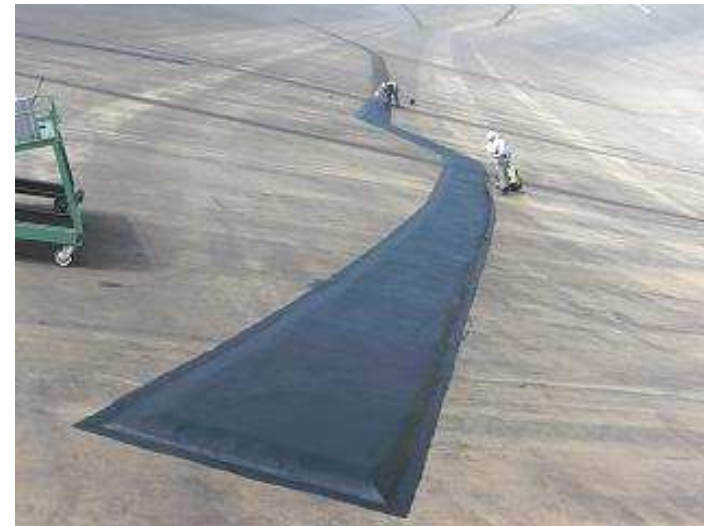
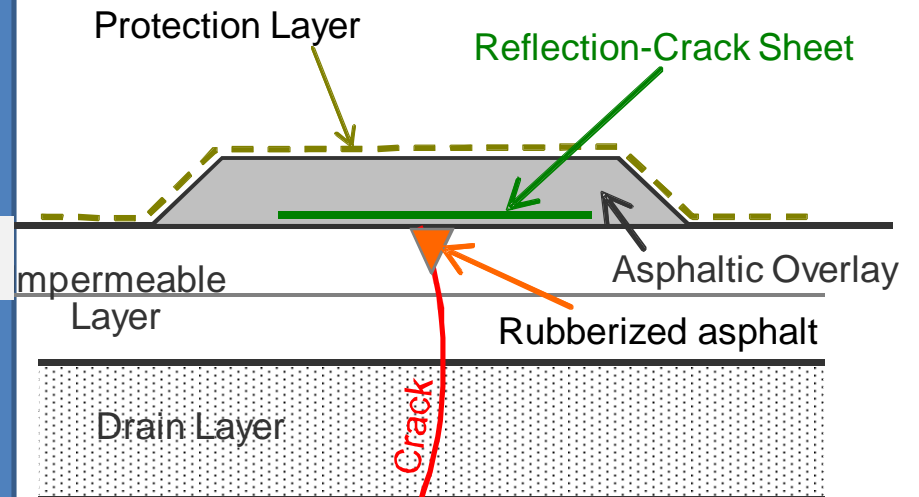
# REMEDIAL WORKS
